**EROSION AND NUTRIENT CONTROL
PROJECT- Otter Creek Farm Cattle Crossing**

This project, completed in 2016, was designed to improve water quality in the Slate River Watershed. We believe that the partnerships developed with the Thunder Bay Soil and Crop Association, local farmers and The North Shore Steelhead Association will lead to improved water quality in Lake Superior and its tributary watersheds by creating protected “Riparian Zones” or Buffer Zones next to local streams.

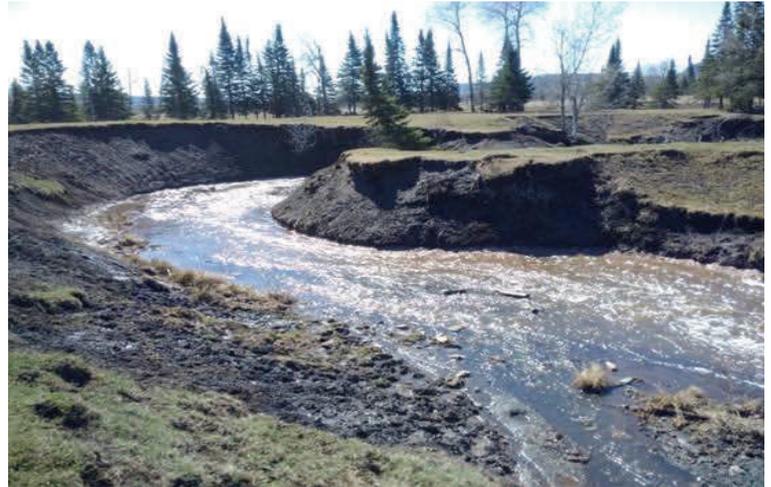
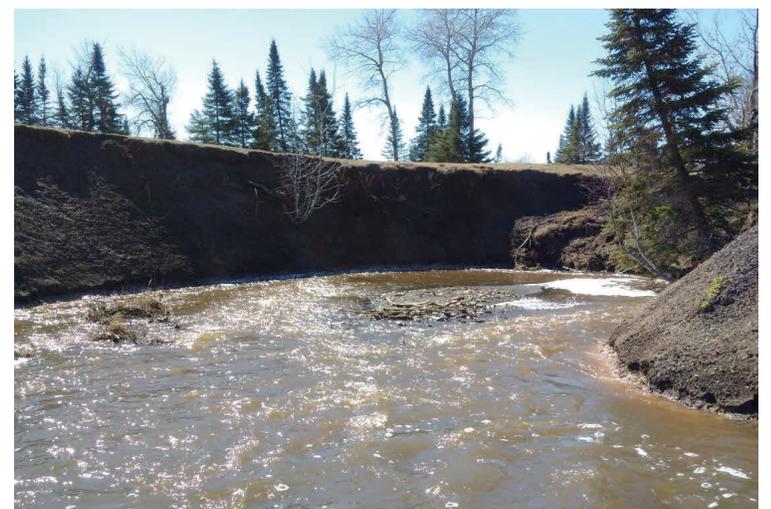
April 2016– Eroding Streambanks– Before Work

Project Funding – A \$25,000.00 grant was received through the Great Lakes Guardian Community Fund. This grant covered all of the work completed to re-slope the stream banks, stabilize unstable areas with rip-rap and create a 30 metre long cattle crossing. Stream banks were live-staked with willow, red-osier dogwood, and poplar.

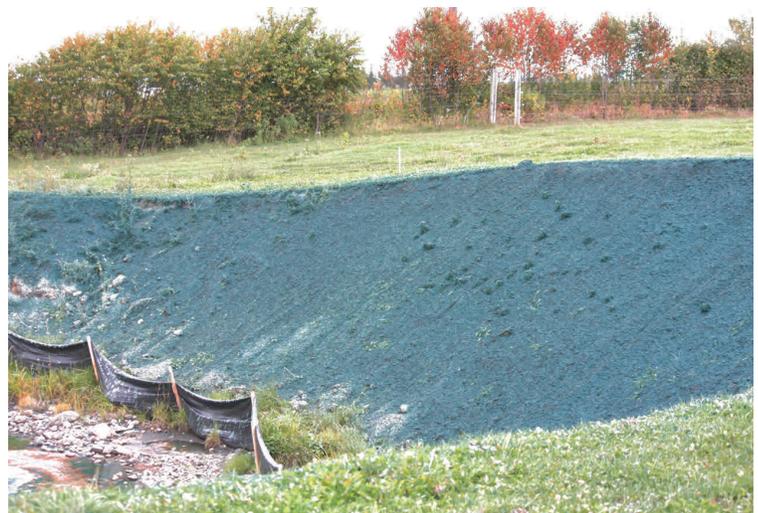
Stream Banks were re-sloped and hydro-seeded.

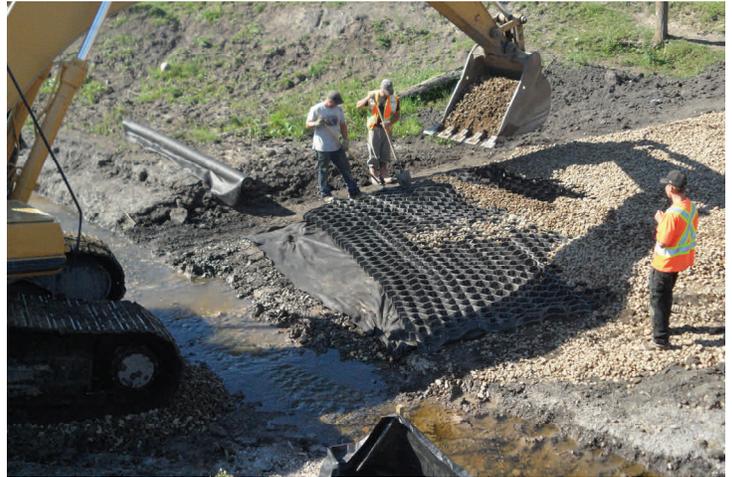
Geotextile and cobble were laid on the base of the cattle crossing. Jack Hansen covered the cobble with granular A to make it a more stable surface for the cattle to walk on.

A 30 metre cattle crossing was constructed during the low water period in July, 2016. Geotextile was laid underneath the crossing and was filled with 4-6 inch cobble to resist the Spring freshet and flood events along Otter Creek. This crossing has only been tested by moderate high water events so far. A small section of geotextile was eroded during Spring and had to be filled by Jack Hansen using cobble and rip-rap.
